# STREAM OF

Protecting the  
golf course from  
an encroaching  
stream presented a  
Pennsylvania club  
with an opportunity  
to make a significant  
environmental splash.

# CONSCIENCE

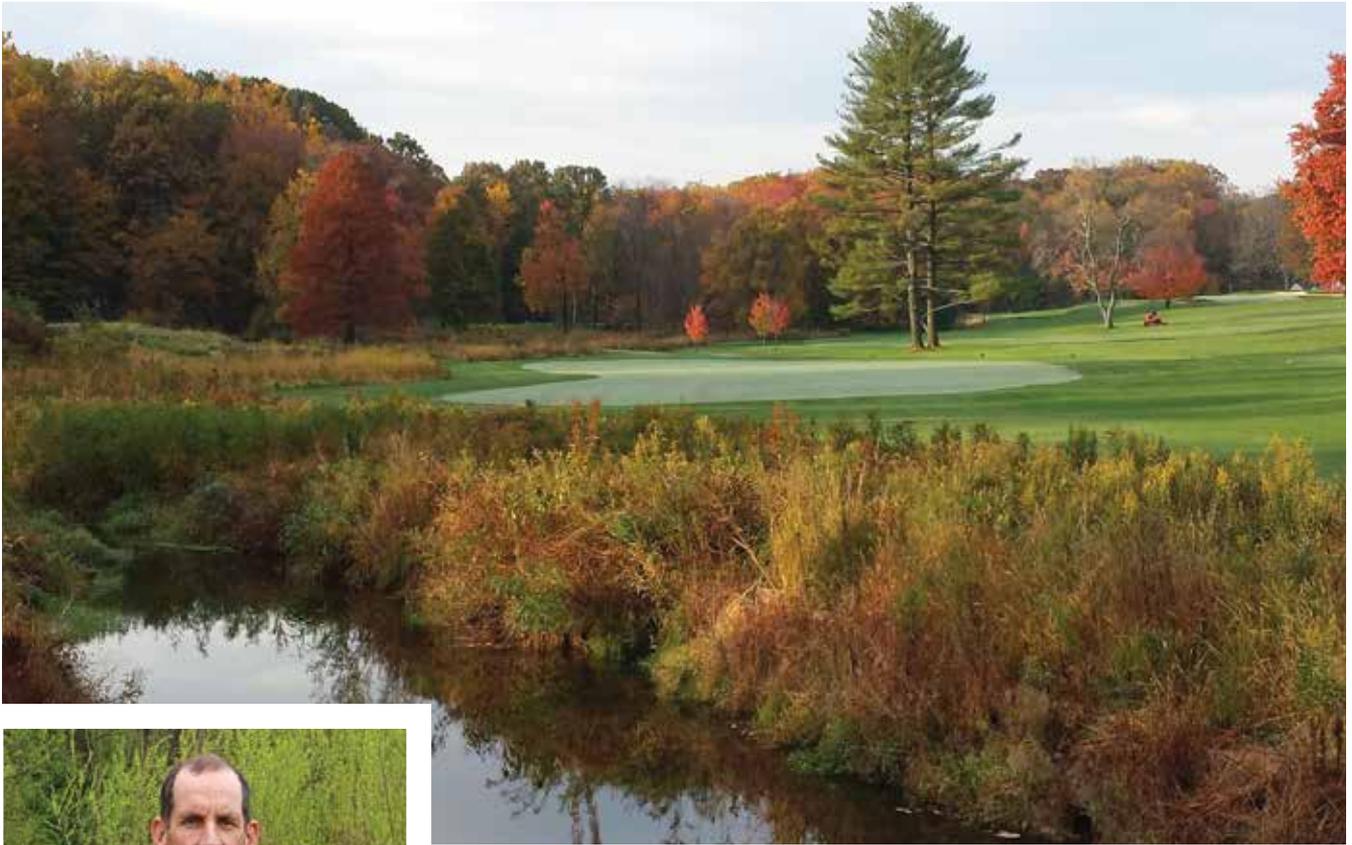
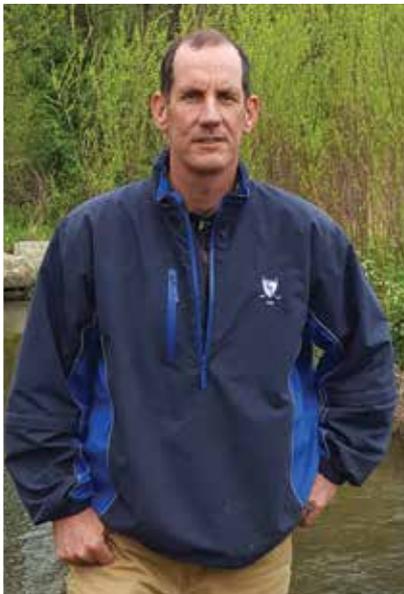
Paul Stead, CGCS, faced an intruding stream that hindered play and threatened course infrastructure when he began overseeing Kennett Square (Pa.) Golf and Country Club in 2005. Twelve years later, the transformed stream (top) is not only no longer a risk, but is an asset within the Red Clay Creek watershed. In recognition of KSGCC's stream restoration initiative, the Red Clay Valley Watershed Association honored the club with its 2014 Outstanding Conservationist award. Photos courtesy of Paul Stead

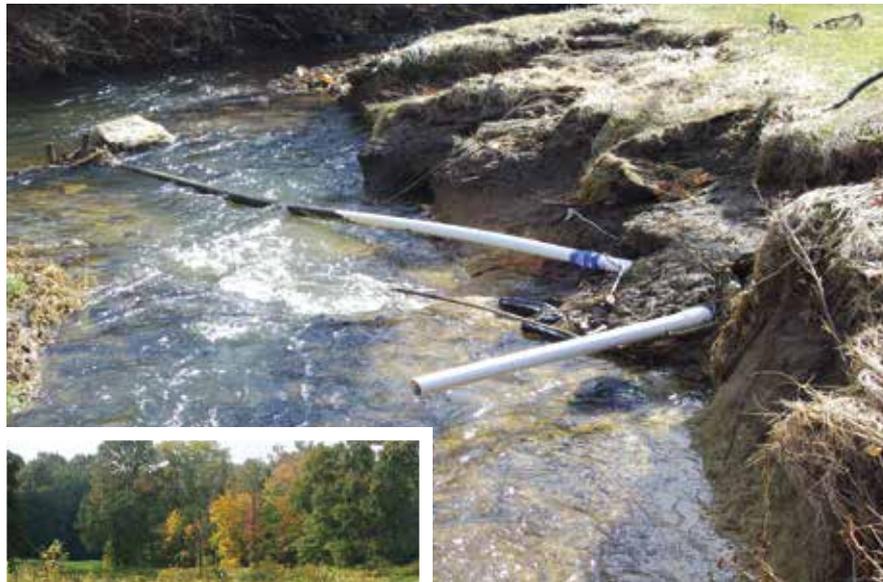
**Above:** Exposed irrigation pipes on KSGCC's 14th fairway following a thunderstorm in 2010.

While the stream bank erosion had started as just a little here and there, it had picked up momentum as the years passed. If no action were taken, the 14th tee would have eroded within two years, and three bridges over the stream were in danger of being washed out during storms. As the stream infringed upon the 14th fairway, irrigation pipes were becoming exposed, and if left unchecked, the pipes would have eventually blown out.

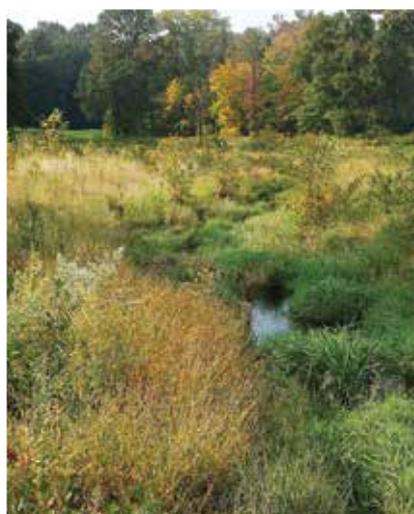
**Left:** Completed restoration work on the tract of Red Clay Creek that travels the 14th fairway. To the right of the stream is a reforested section of land, connecting the stream corridor to existing woods. Shrubs lining the stream include serviceberry, winterberry and several *Viburnum* species.

and plant species was central to this project. Only herbaceous vegetation was planted in areas where visibility down the fairway was necessary. The remaining floodplain was planted to tree and shrub species to provide habitat as well as shade the stream (lowering the water's temperature allows it to better support aquatic wildlife). An exceptionally diverse palette of native plants was installed to maximize biodiversity and supply a food source for native songbirds along with wild bees and butterflies. Construction of the renovated stream corridor wrapped up in May 2012.

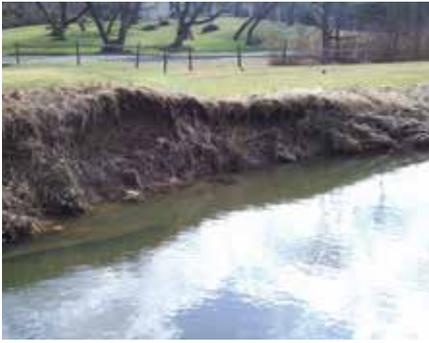
**Above:** Severe erosion encroaching on the 14th tee in 2010.

Deteriorating banks were bringing the stream extremely close to the 13th green and 14th tee. Flooding could cause 3 to 4 feet of bank to disappear overnight. After flooding, which would occur several times in summer, water would be impounded on the 14th fairway by a berm that had built up over time from sediment deposited during previous flooding. Up to two days could be required for the water to recede and the fairway to dry out enough to accommodate carts. If the stream flooded during an event, such as the member-guest tournament, the entire fairway may not have been playable for the remainder of the tournament.

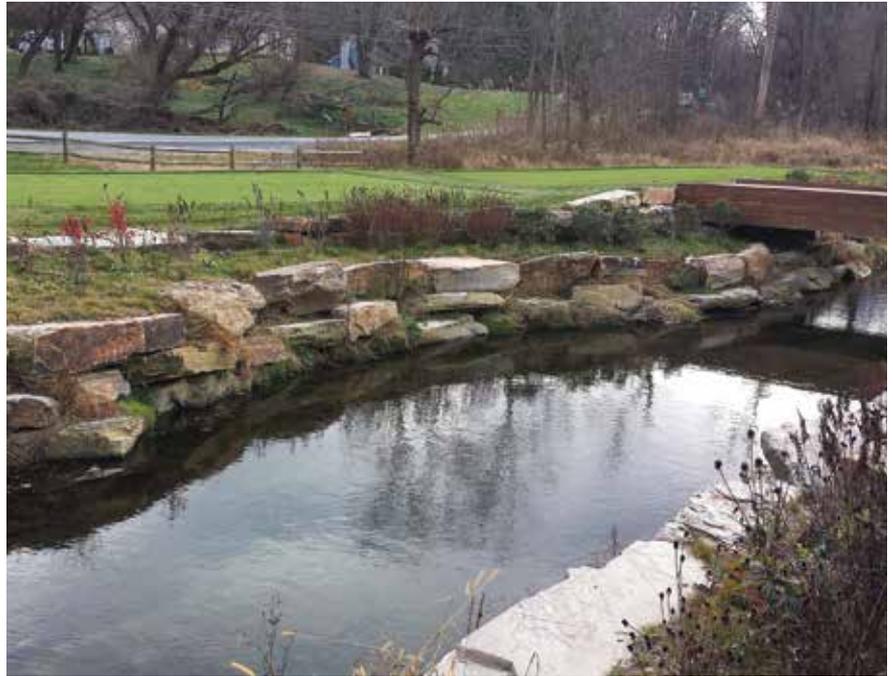
**Right:** The same area after the finished stream corridor restoration in 2012. This stone wall is unique among the restoration work, stacked higher because the banks could not be pulled back given their closeness to the 14th tee and 13th green. The stone was selected at a local quarry to match the color of KSGCC's stone clubhouse.

In map view, the pre-restoration stream was a straightened channel made mildly sinuous by roughly 80 years of erosion. This geometry was only slightly altered in the restoration, as the focus was more on the stream's banks than its path. Boulder banks were constructed along concave (erosion-prone) channel bends, and large woody debris was integrated for in-stream habitat enhancement where feasible. Woven willow branches were used to stabilize a smaller section of stream bank where proximity to the green prohibited lowering the bank's angle. A piped section of a tributary that originates on a neighboring property was “daylighted” and revived as an aboveground stream.

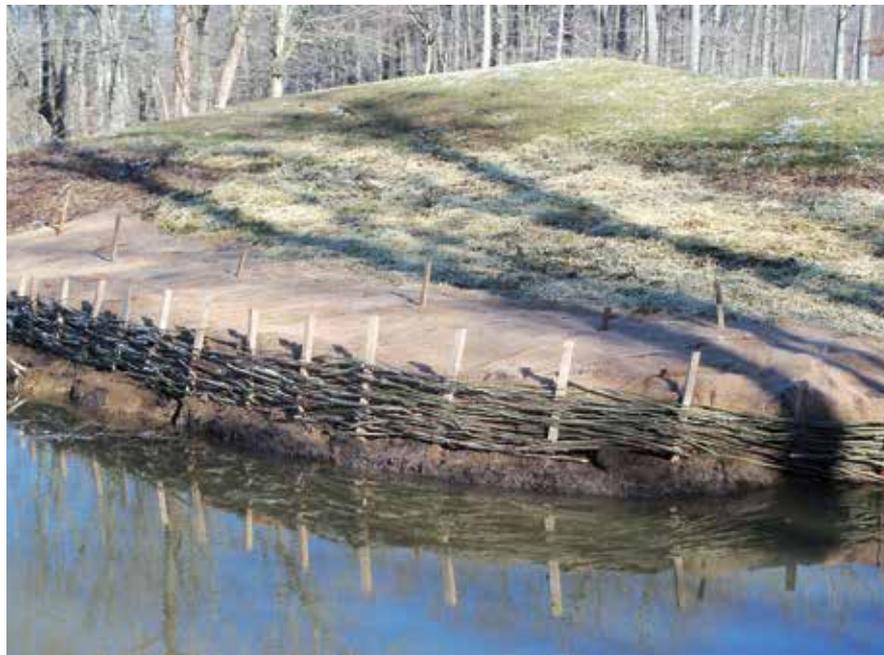
Woven willow forms a natural barrier that withstands and deflects stream water flow behind the 15th green. This bank stabilization technique is known as “spiling.”
